Service Bulletin

Bulletin No.: 21-NA-215

Subject: Pop Noise Heard on Heavy Acceleration Only, Lack of Power When on the Highway, Stall- Multiple DTC's or No DTC's Set

Brand:	Model:	Model Year:		VIN:		Engine:	Transmission:
		from	to	from	to		
Buick	Encore GX	2021	2022			LIH L3T	
Chevrolet	Trailblazer (VIN M)

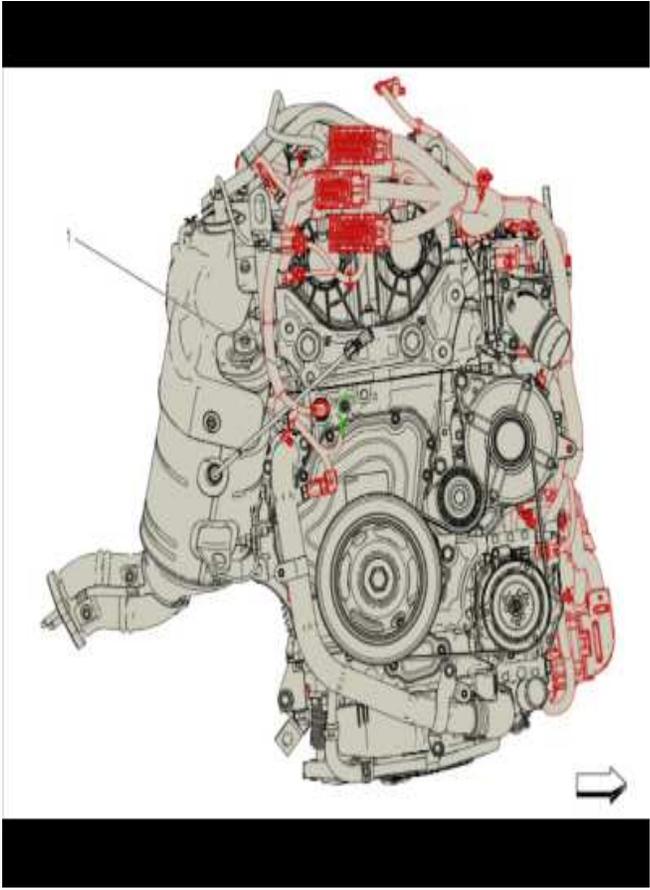
<p style="text-align: right;">5925499</p> <p>G106 L3T ground wire location This condition may be caused by a loose ground located at G106 (1). – The G106 ground nut may not have been tighten to specifications from the factory.</p>
<p>Correction</p>	<p>Locate the G106 ground. Inspect the stud and replace if needed, then tighten nut.</p>
